August 13, 2024

Subject: Road Deactivation and Reactivation Assessment: Stewardson Camp Road Network

Onsite File #: 988-5-4
EGBC PERMIT TO PRACTICE: 1002678

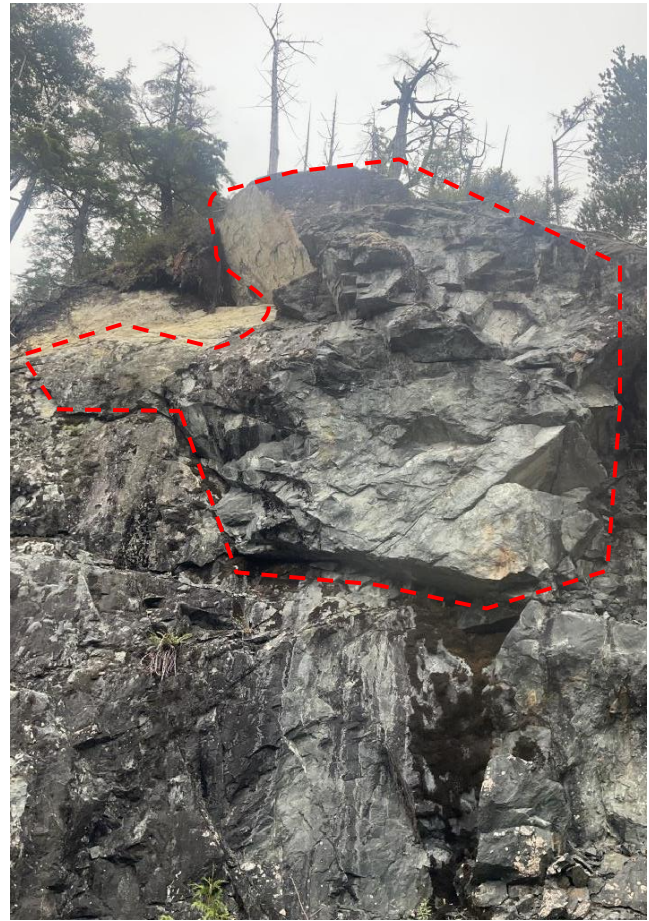
1b

Conditions of rockface during the 2024 assessment, showing potential additional rockfall (red outline). Taken July 17, 2024

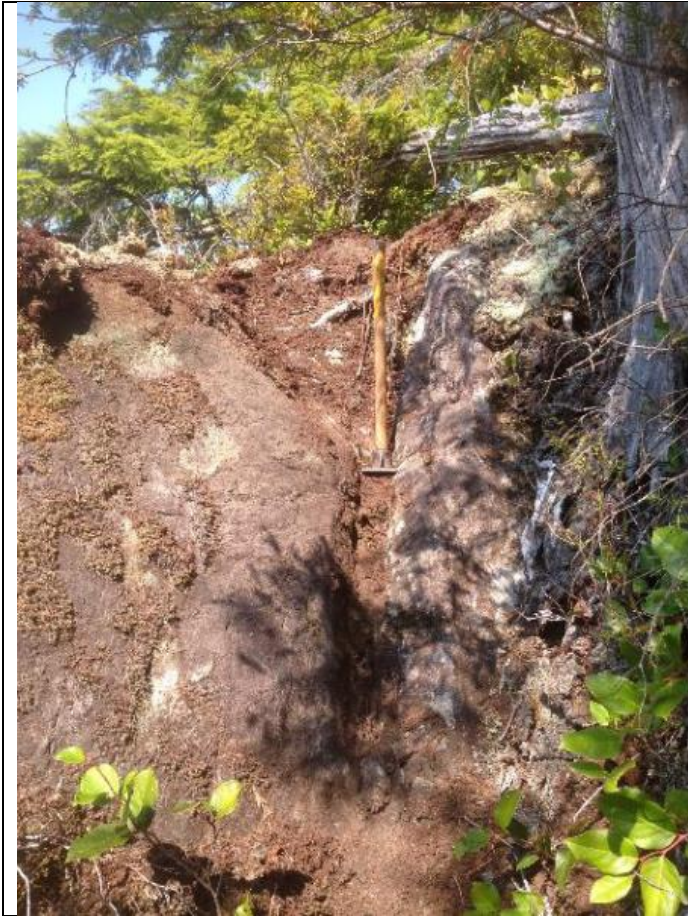
Photo 2:
Deep soil filled fracture noted on 2014 site visit, showing possible widening through root growth. Taken July 17, 2024

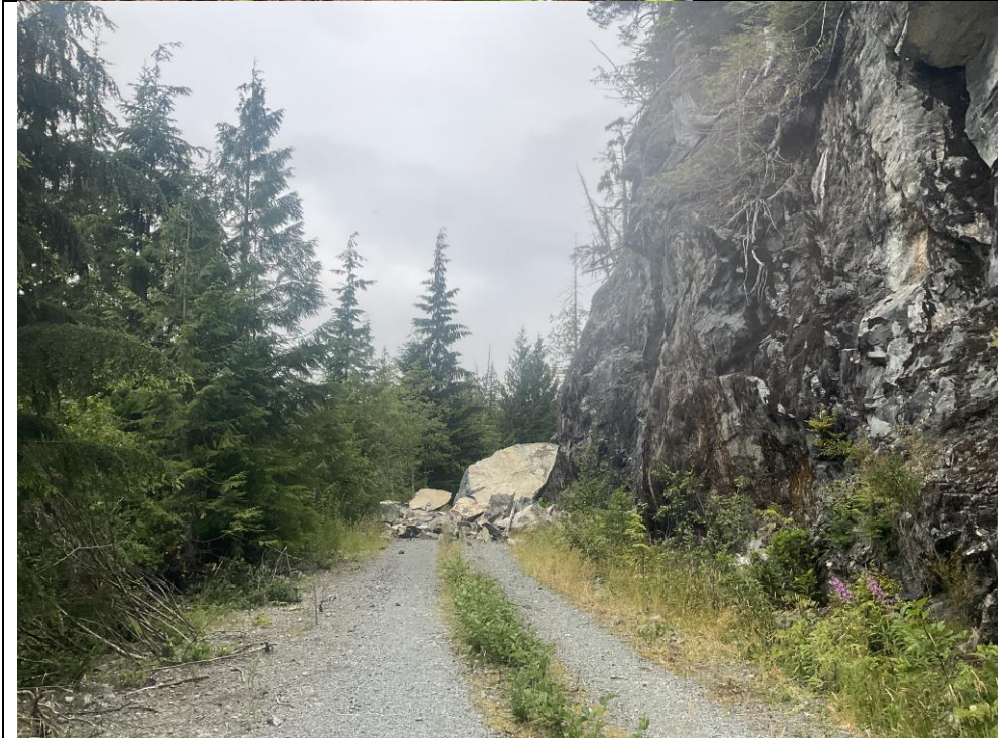
Photo 3:
View looking down-chain. Taken July 17, 2024

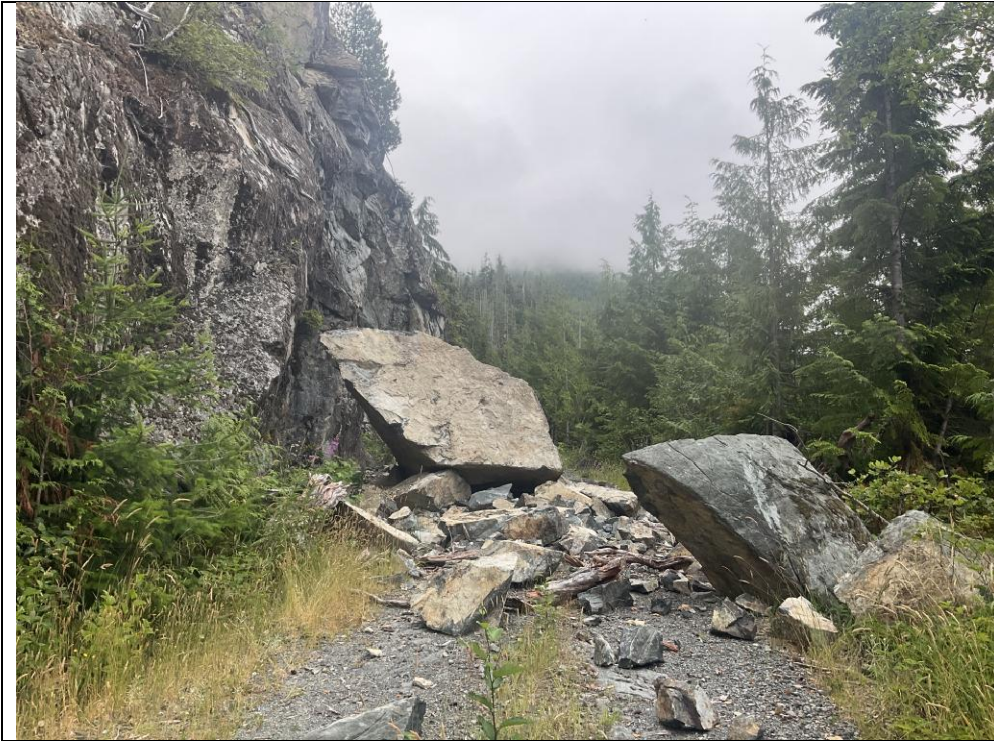
Photo 3:
View looking up-chain.
Taken July 17, 2024

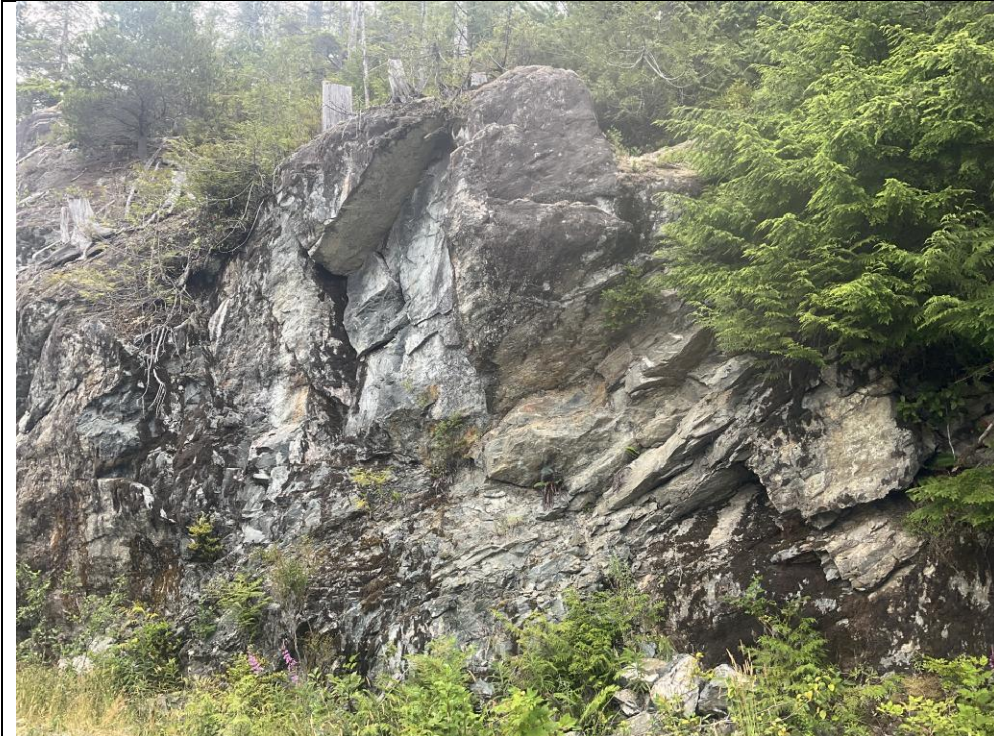
Photo 4:
Potential additional
rock fall site at 5.2 km.
