September 20, 2024

Subject: Road Deactivation and Maintenance Assessment: Bedingfield Road Network

Onsite File #: 988-5-5
EGBC PERMIT TO PRACTICE: 1002678

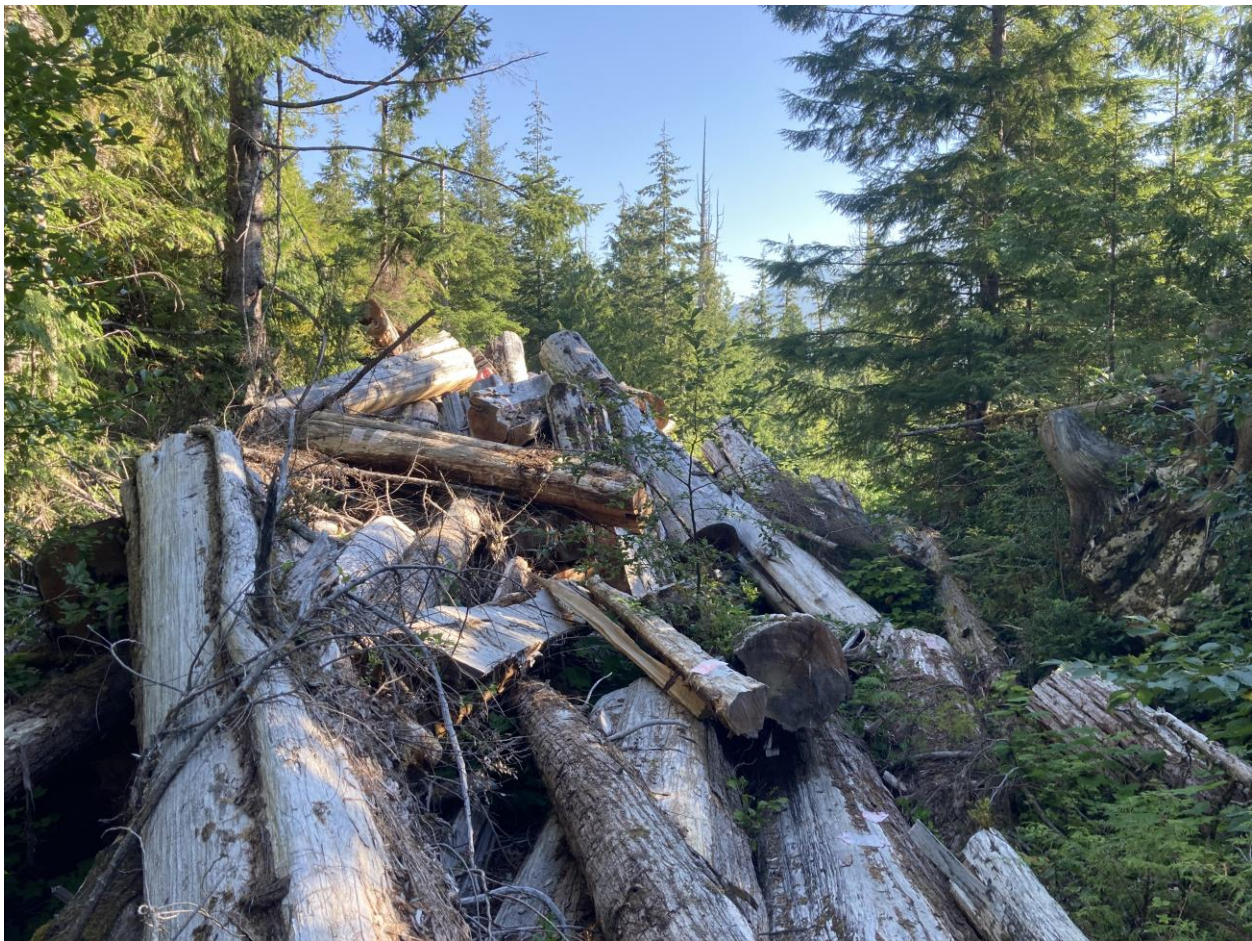
Branch S200 and the back end of East Summit Main were blocked by very large piles of salvage wood and were not accessible at the time of the assessment. As a result, neither of these road intervals were assessed for road deactivation.

Figure 3: stacked timber on East Summit Main
