August 13, 2024

Subject: Road Deactivation and Reactivation Assessment: Stewardson Camp Road Network

Onsite File #: 988-5-4
EGBC PERMIT TO PRACTICE: 1002678

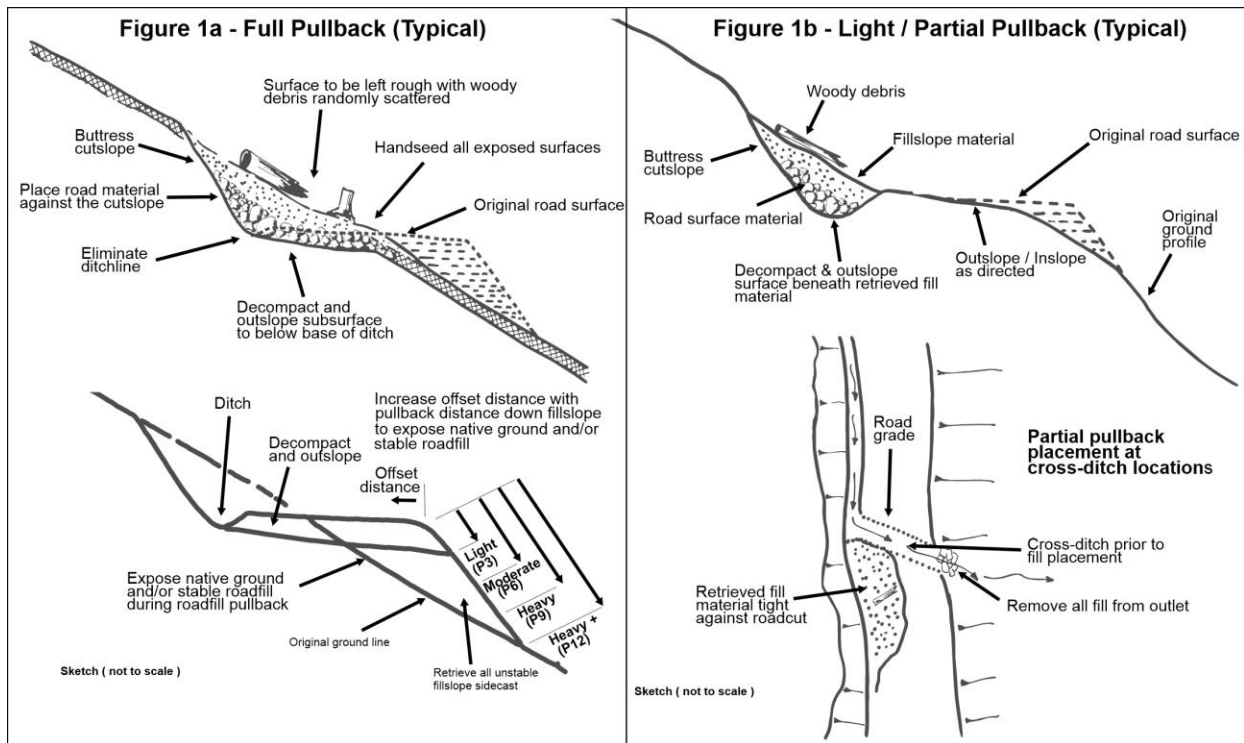
Figure 1: Typical pullback methods (1999 FRBC, Technical Standards and Guidelines for Road Deactivation/Restoration Activities)

Light pullback – Tension cracks and settling on outer 1-2 m of road, windrows or large berms present; likely only a thin wedge of fill material present. Remove side cast material built up on the outside shoulder. All side cast with the potential to start a landslide must be retrieved. (Figure 1b).

Moderate pullback (discretionary) – Failing fill slope, tension cracks and settling on outer +2m of road; likely a thicker wedge of fill. Comb fill slope material back to original ground surface or until coarse and rocky material remains. **The objective is to comb-back the fill, ensuring that there is no lip remaining at the toe of the pullback.** This may require all fill material to be pulled back. All side cast with the potential to start a landslide must be retrieved.

Heavy pullback (full) – In thick fills where entire fill slope is or may become unstable and large tension cracks or fill slope failures are present or starting to fail, pull back fill slope material to original ground. All

side cast with the potential to start a landslide must be retrieved. Where full (heavy+) pullback is prescribed and where safety permits, benching downslope to retrieve all fill material may be required.

Road fill pullback is recommended along some sections to stabilize the roads for the long term. The length of pullback is indicated in the prescriptions (i.e. light (P3), moderate (P6), heavy (P9), and heavy+ (P12)) as an estimate of slope distance from the crest of the fill slope/edge of the road (Figure 1a). Additional pullback may be needed at some locations if more road fill is present than evident from the visual inspection during the work.

All fill should be placed along the inside edge of the road, removing the ditch line completely.
