September 20, 2024

Subject: Road Deactivation and Maintenance Assessment: Bedingfield Road Network

Onsite File #: 988-5-5
EGBC PERMIT TO PRACTICE: 1002678

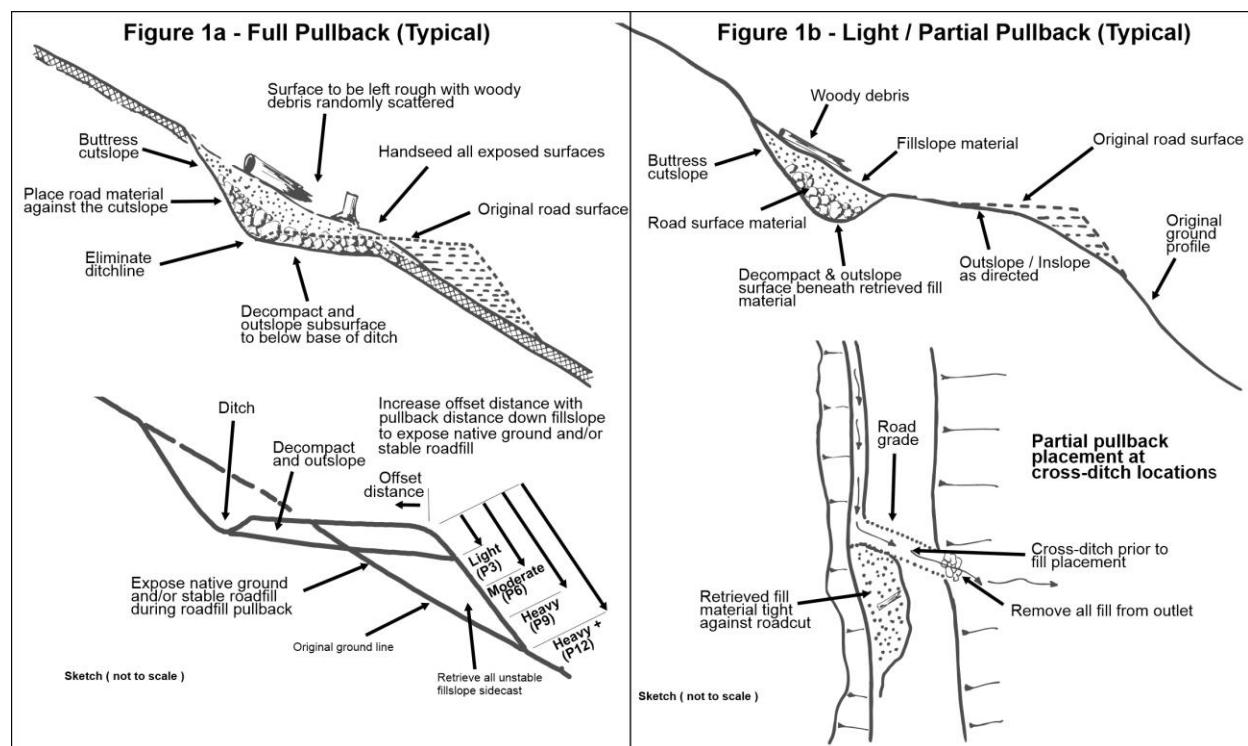
Figure 2: Typical pullback methods (1999 FRBC, Technical Standards and Guidelines for Road Deactivation/Restoration Activities)

Light pullback – Tension cracks and settling on outer 1-2 m of road, windrows or large berms present; likely only a thin wedge of fill material present. Remove side cast material built up on the outside shoulder. All side cast with the potential to start a landslide must be retrieved. (Figure 1b).

Moderate pullback (discretionary) – Failing fill slope, tension cracks and settling on outer +2m of road; likely a thicker wedge of fill. Comb fill slope material back to original ground surface or until coarse and rocky material remains. **The objective is to comb-back the fill, ensuring that there is no lip remaining at the toe of the pullback.** This may require all fill material to be pulled back. All side cast with the potential to start a landslide must be retrieved.

Heavy pullback (full) – In thick fills where entire fill slope is or may become unstable and large tension cracks or fill slope failures are present or starting to fail, pull back fill slope material to original ground. All side cast with the potential to start a landslide must be retrieved. Where full (heavy+) pullback is prescribed and where safety permits, benching downslope to retrieve all fill material may be required.

All fill should be placed along the inside edge of the road, removing the ditch line completely.
